Manhole Inspection Summary

Manhole # S37A__017MH

Insp Date: **9/18/08 1:58 PM**

Location Address: **side of 500 the fallsway**

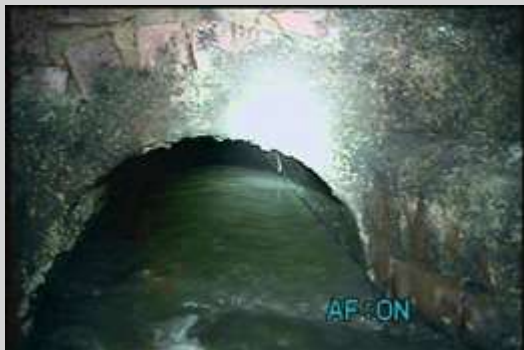
12 O'Clock Outflow

15 in. Circular Gravity Sewer
Pipe Out @ 12 O'Clock

Pipe Material: **Clay** ☐ Pipe Lined

Invert Depth: **12.00** (ft.) Flow Characteristics: **Fast**

Deposits: ☒ None ☐ Mud ☐ Sludge ☐ Debris ☐ Grease

Infiltration: **None** Pipe Seal Cond: **Unknown**

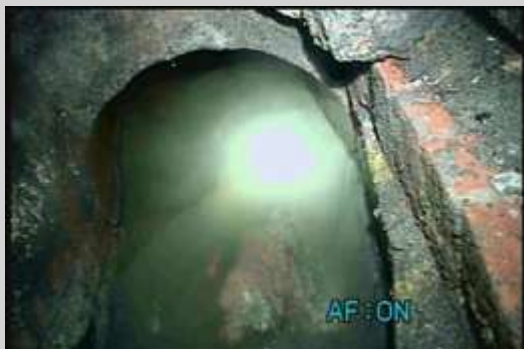
3 O'Clock Inflow

12 in. Circular Gravity Sewer
Pipe In @ 3 O'Clock

Pipe Material: **Clay** ☐ Pipe Lined

Invert Depth: **11.57** (ft.) Flow Characteristics: **Fast**

Deposits: ☒ None ☐ Mud ☐ Sludge ☐ Debris ☐ Grease

Infiltration: **None** Pipe Seal Cond: **Unknown**

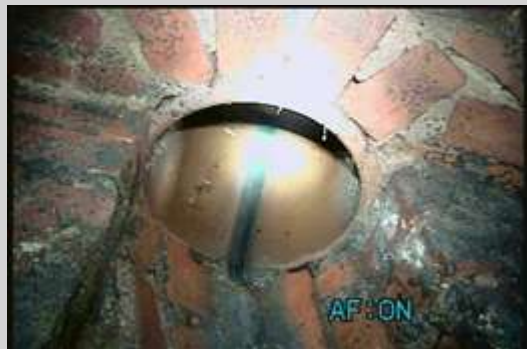
9 O'Clock Inflow

8 in. Circular Gravity Sewer
Pipe In @ 9 O'Clock

Pipe Material: **Clay** ☐ Pipe Lined

Infiltration: **None** Pipe Seal Cond: **Unknown**
